Manhole Inspection Summary

Manhole # S31KK1008MH

Insp Date: **2/27/07 9:55 AM**

Location Address: **45 WARRENTON RD**

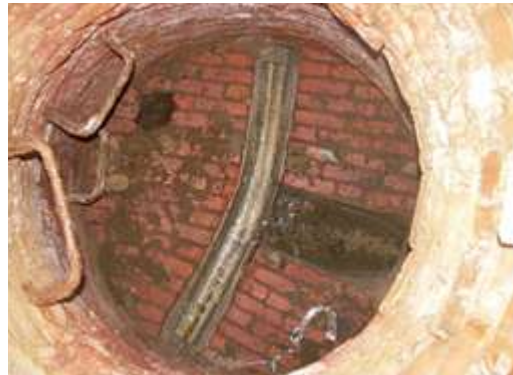
Top View

Corroded steps. Bench and Channel debris.

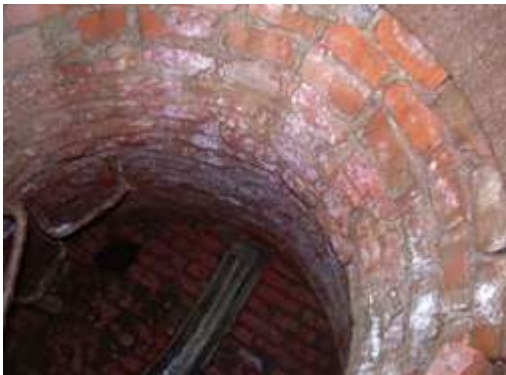
Defect

Frame leaks. Adjustment deterioration, loose brick and infiltration.

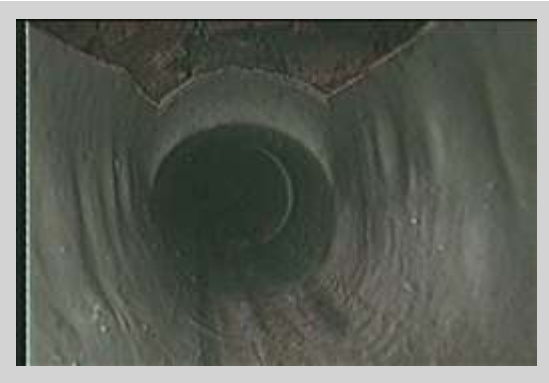
8 in. Circular Gravity Sewer Pipe Out @ 12 O'Clock

Infiltration: **None** Pipe Seal Cond: **Cracked**

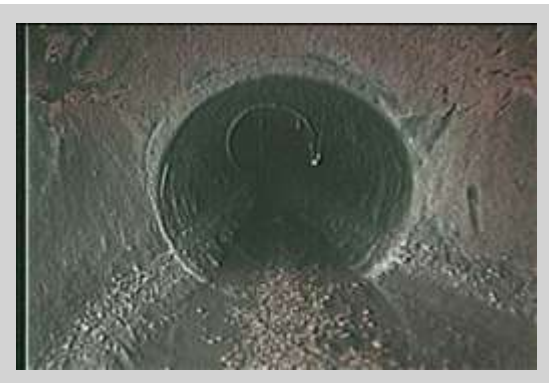
8 in. Circular Gravity Sewer Pipe In @ 4 O'Clock

Deposits: ☐ None ☒ **Mud** ☐ Sludge ☒ **Debris** ☐ Grease

Silt Depth: **0.5** (in.) Deposits Extent: **Light**

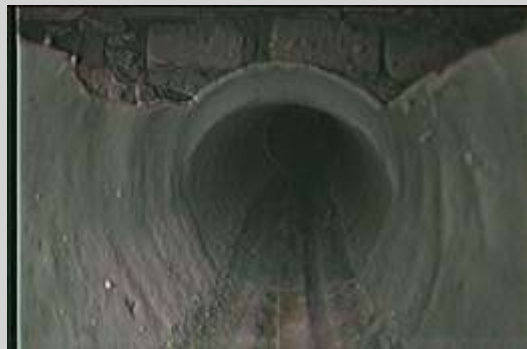
Pipe In @ 7 O'Clock

Barrel deterioration and infiltration.

Pipe Seal Cond: **Cracked**
